Arboricultural Impact Assessment

Llyn Tegid (Bala Lake) Reservoir Safety Project

Black & Veatch Ltd

Our Ref: 19/AIA/SNP/10

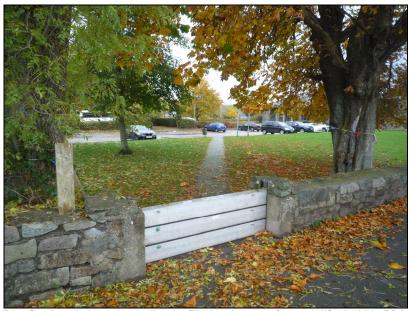
P1 – Gap in existing wave wall to be filled and tarmac footpath lifted within RPA Of tree numbers 96 & 97

- The public footpath that runs between tree numbers 96 and 97 is to be moved to a new location to the east and the gap in the existing wave wall in this location is to be filled to match the wall either side. This will involve lifting the existing tarmac surface dressing within the RPA of the trees and excavating within the gap in the wall to install the necessary block foundation for the inlay wall section as detailed on Black & Veatch Drawing Ref: 122918-BVL-Z0-00-DR-C-100007 (Rev P03) and in the engineer's cross section drawing below. All excavation works within the RPA of trees will be undertaken by hand and under the direct on-site supervision of the project Arboricultural Consultant see Arboricultural Method Statement.

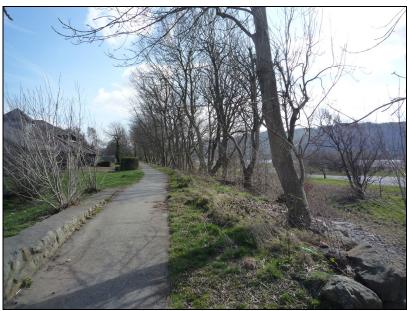
P2 – Group 1 viewed from footpath west of Leisure Centre. Note all trees have been topped out at 9m resulting in weak secondary crown above

- 8.3 The principal impact will be the removal of tree groups 1 and 4-8 that form linear closed canopy groups on the embankment to the south of the footpath around Llyn Tegid reservoir. These trees have naturally colonised this embankment due to lack of any past formal site management and they should be considered for removal as appropriate management of the existing embankment. A significant number of these trees display evidence of Ash Dieback (*Hymenoscyphus fraxineus*) that will lead to their inevitable early demise. All have seen significant crown reductions/topping leaving an unnatural appearance and poor structural forms with potential to fail due to the adventitious secondary crowns having a weak attachment to the parent stem. These trees have exploited the small gaps between boulders that make up the embankment and most have now outgrown their confined rooting environment and exhibit multiple physiological and morphological disorders as a result. As such, remedial tree management works are required irrespective of the proposed works.

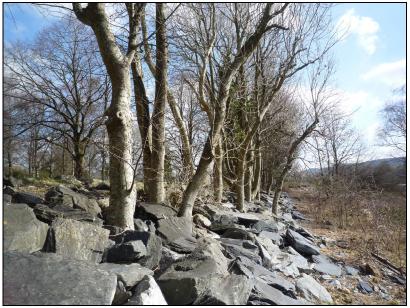
P3 – Base of trees in G1 growing out between gaps in existing embankment.

Many boulders have become embedded in stems & there is insufficient space for further establishment without potential fractures

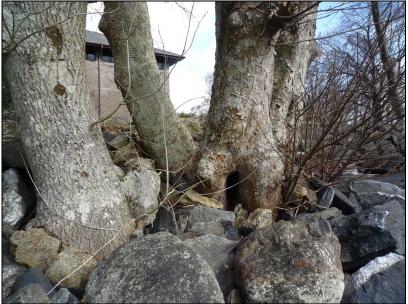
P4 – Embedded rocks/boulders and physiological disorders to base of stems in G2. Trees have limited long-term potential irrespective of proposed works

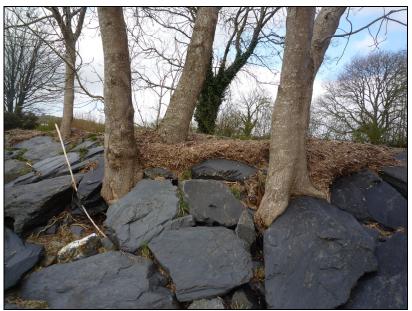
P5 – Embedded rocks/boulders at base of stems on group 4. These cause potential fracture points when trees are loaded or during inclement weather

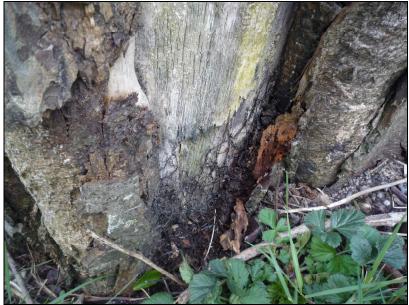
P6 - Rhizomorphs of Honey Fungus at base of T9

Т9	Horse Chestnut	EM	10 2W	4.5	3	5	3	560	Р	 Horse Chestnut Bleeding Canker present on stem Honey Fungus evident at base Tree is in decline E.R.C 0 Remove for H&S Remove for H&S E.R.C 0 	6.7m 142m ²
T10	Horse Chestnut	EM	9	4	4	4	5	470	M	 Horse Chestnut Bleeding Canker present on stem Appears stressed & in decline E.R.C 0 	5.6m 100m ²

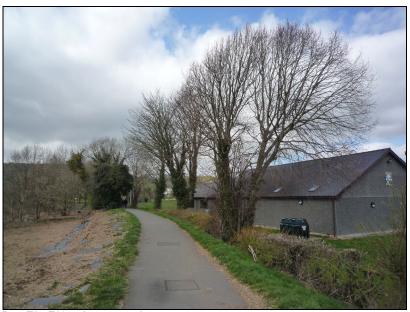
P7 – T25-T29 to be removed

T24	Lime	M	15 4S	5	2.5	6	6	500	G	 Part of linier group within boundary hedgerow adjacent to rugby club No significant defects E.R.C 20 	Remove for proposed works	B2	6m 113m²
T25	Ash	EM	13 0	1	5	1.5	5	400	G	 Self-set tree with suppressed crown form due to proximity to T22 & T23 E.R.C 10 	Remove for proposed works	C2	4.8m 72m ²

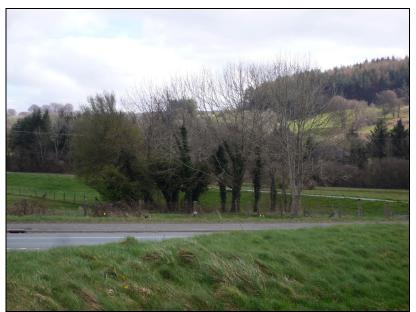
P8 - G12 & G13, small unmanaged lvy clad trees to be removed

G13	Cherry Plum	М	≤12	2	2	5	2	≤200	G	 No visual defects Easily replaced post completion of works E.R.C 10 	Remove for proposed works	C2	2.4m 18m²

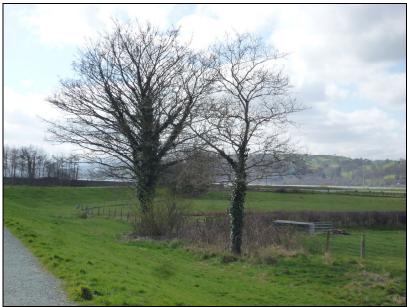
P9 - T35-T37, semi-mature/early mature small diameter trees

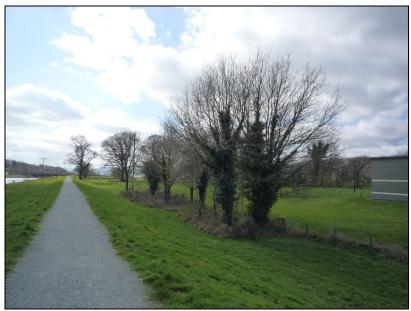
P10 - T41-T49 forming small linear copse of lvy clad trees

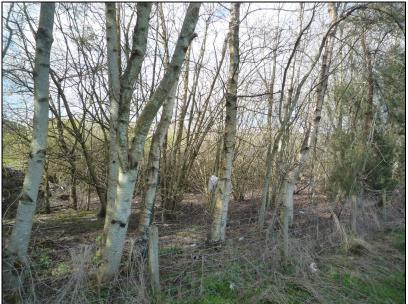
P11 - Group 14, linear group screening industrial area beyond

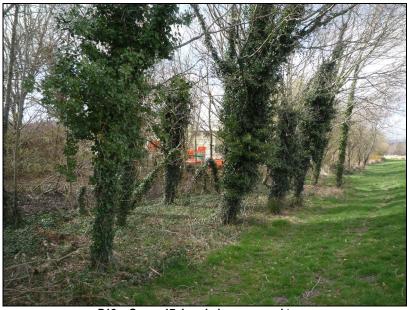
P12 - Group 17, Ivy clad unmanaged trees

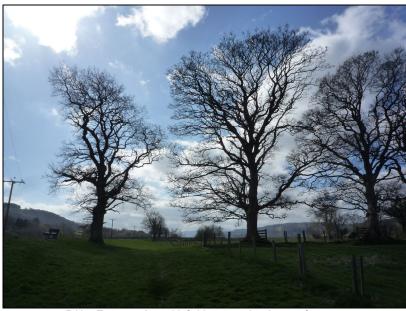
P13 - Tree numbers 38 & 39 mature landscape features
