**Llyn Tegid Reservoir Safety Project**

**Invasive Species Management Plan**

**November 2019**

Drawing title: **INVASIVE SPECIES LOCATION PLAN**

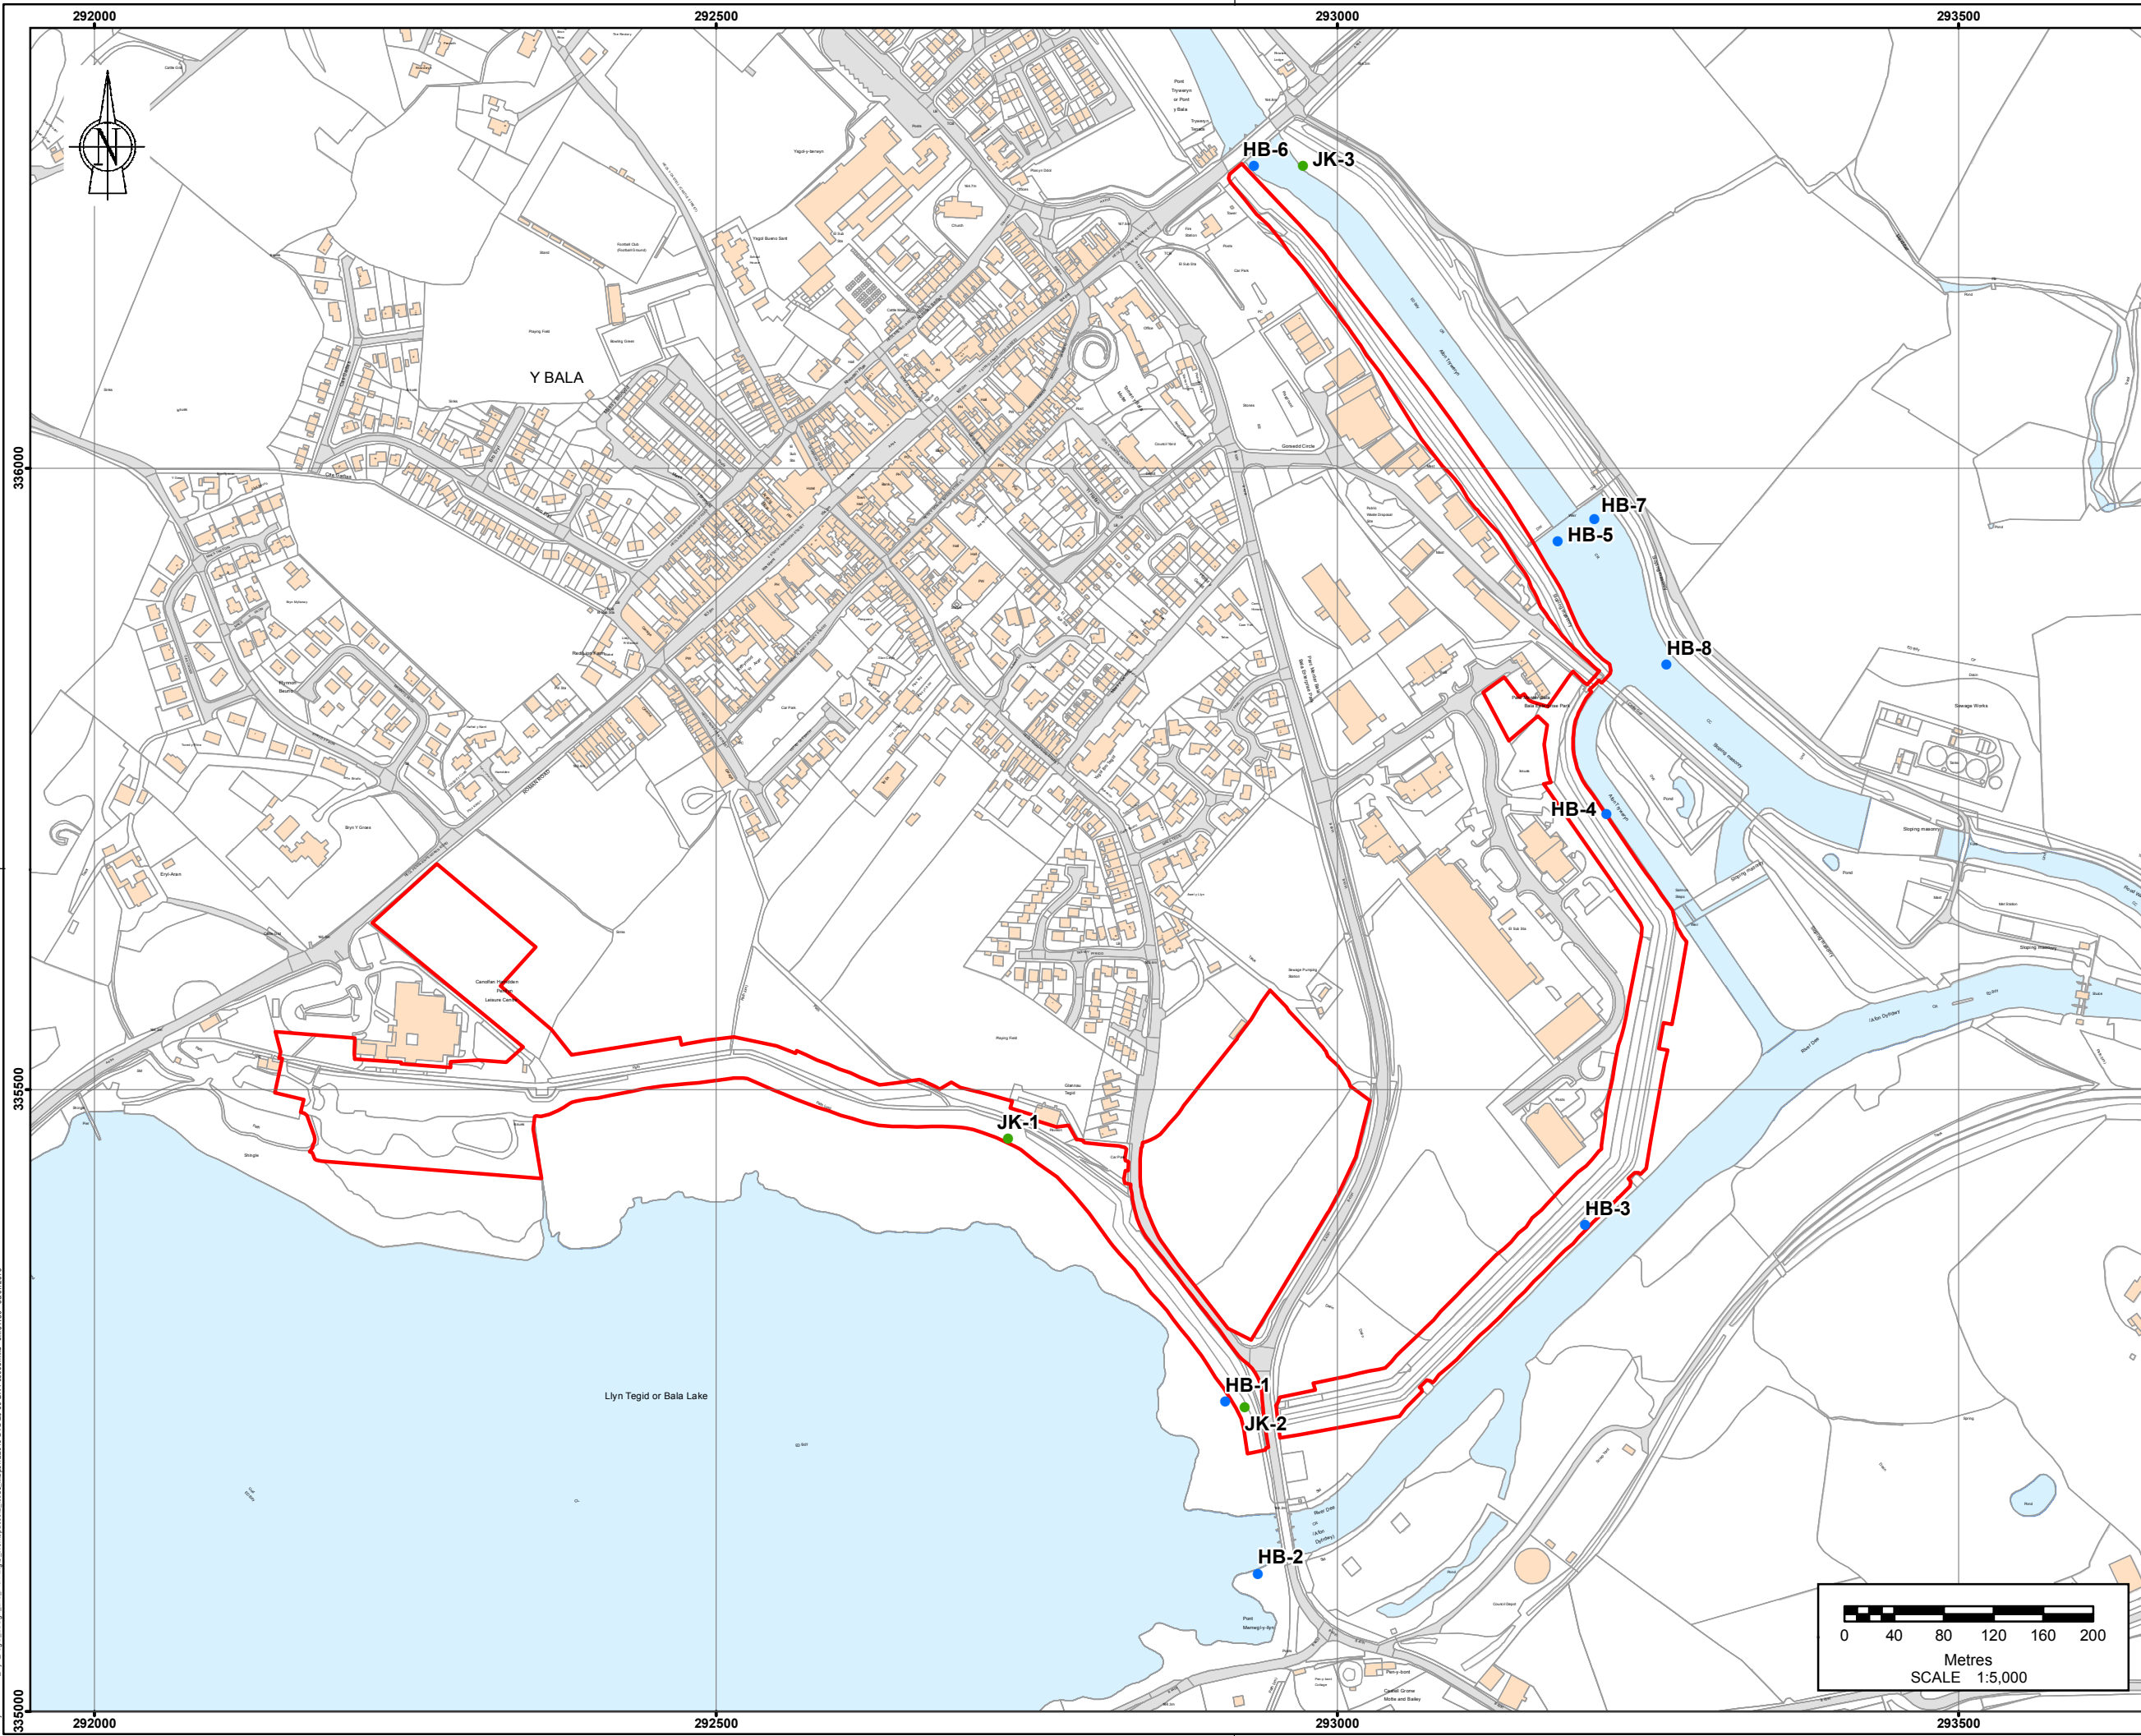
HB is spread throughout the entire riverbank (Dee and Tryweryn) with concentrated points and surveyed locations shown on the locations plans contained in Appendix A. Stands of HB which could be impacted by the works are summarised in Table 1.1.

The three surveyed locations for JK are shown on the location plan contained in Appendix A and the two locations which could be impacted by the works are summarised in Table 1.1.

**Table 1.1 Reach 1 invasive species locations (as of 17<sup>th</sup> July 2019)***(Table 1.1 should be read in conjunction with drg 122918-BVL-Z0-00-DR-I-00008 in Appendix A)*

Location Reference	Description	Approximate grid reference
HB-1	Dense stands of Himalayan balsam within the scrub and nettles in the southern lakeshore. The balsam was concentrated inland near the embankment, with scattered individuals closer to the lake. The stands could be within the construction working area and impacted by works to lake embankment.	SH 92910 35249
HB-3	Himalayan balsam was present all along this area as widely scattered individual plants. The stands are located on the river side of the embankment while works will focus on the landward side and crest.	SH 93199 35391
HB-4	Throughout this area there are numerous scattered Himalayan balsam plants, essentially everywhere at low density. The plant was found along this entire bank including the large swathe of inundation vegetation to the south. The stands are located on the river side of the embankment while works will focus on the landward side and crest.	SH 93217 35722

HB-5	There were dense stands of Himalayan balsam throughout this area, including on numerous small river islands either side of the weir. There were dense stands of this plant on the right (west) bank, and scattered plants throughout, including inland at the top of the embankment and individual plants in the dry ditch to the east behind it. Where located on the embankment crest they will be impacted by the works to resurface the footpath.	SH 93178 35941
HB-6	Small islands have formed in the river here due to the bridge arches. They are covered in inundation vegetation similar to the river margins, including scrub and ruderal vegetation, and clearly flood occasionally. Both contain numerous well established Himalayan balsam. Balsam is also found scattered at the river's edge on both banks in this area, particularly in scrub on the east bank. Where located on the embankment crest they will be impacted by the works to resurface the footpath.	SH 92933 36244

JK-1, JK-2	Two small patches of Japanese knotweed located close to the lake embankment within an area of tall ruderal vegetation. The stands are located within the construction working area but are not located within the existing rip rap.	SH 92735 35461, SH 92926 35245

Numerous stands of Himalayan balsam (HB) are present along the left (north) bank of the River Dee, along both banks of the Tryweryn from the A494 bridge to the confluence with the Dee, and at the lake foreshore close to sluices feeding the Dee.

A third stand of JK is located on the left (east) bank of the Afon Tryweryn just downstream of the A494 bridge. As this stand is located on the opposite bank to where works will take place no impact is considered to occur, therefore no recommendations for treatment are presented here.
